**FIRE-RESISTANCE TEST  
ON DOWNLIGHT COVERS INSTALLED IN  
PLASTERBOARD CEILINGS**

**Report number FSP 1290B**

**SPONSORED INVESTIGATION No. FSP 1290B  
FIRE-RESISTANCE TEST ON DOWNLIGHT COVERS INSTALLED IN  
PLASTERBOARD CEILINGS**

**TEST STANDARD:** Australian Standard 1530, Methods for fire tests on building materials, components and structures, Part 4-2005, Fire-resistance tests of elements of construction.

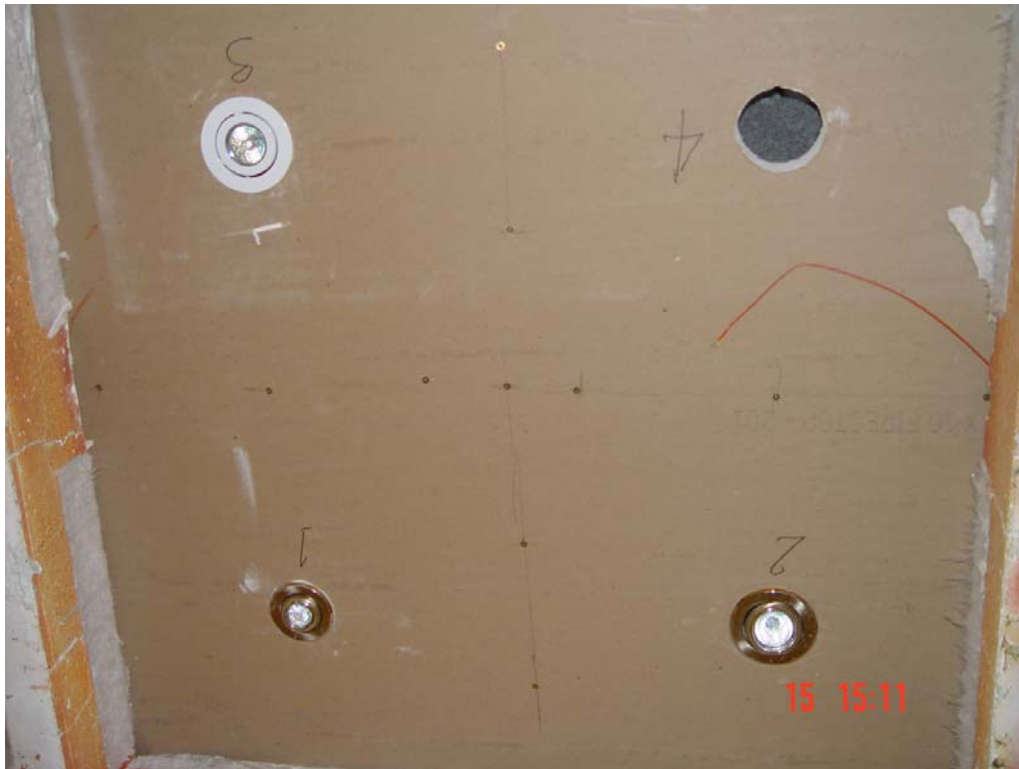
Photograph 1 - Exposed face of the specimen prior to testing

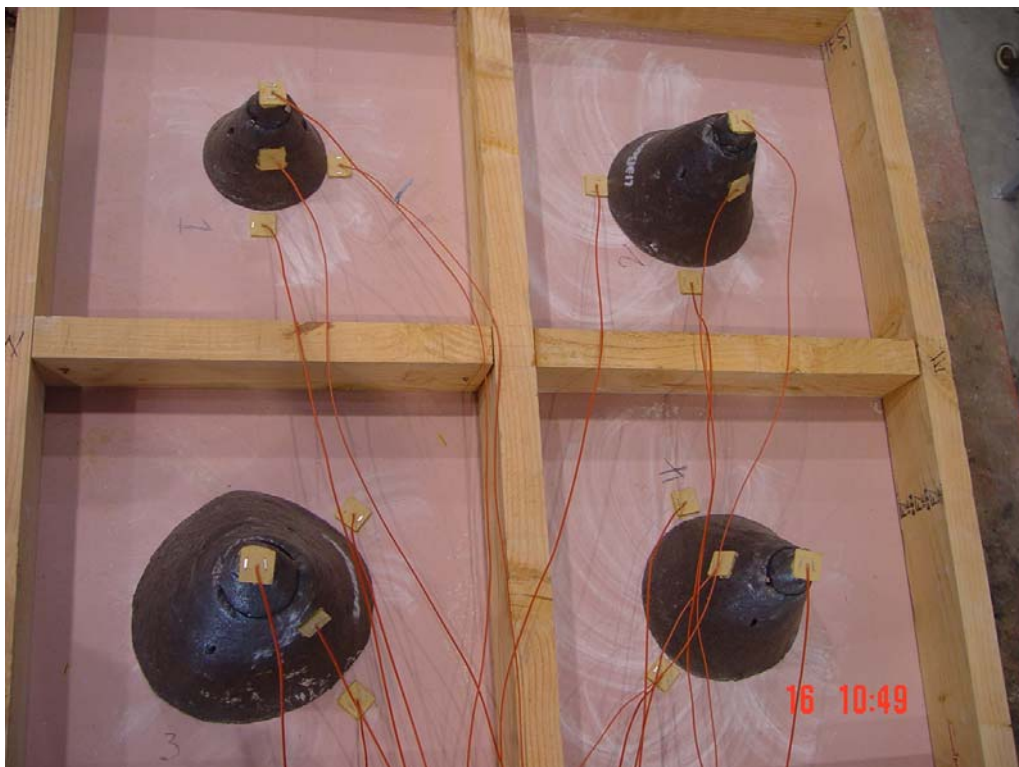
Photograph 2 - Unexposed face of the specimen prior to testing

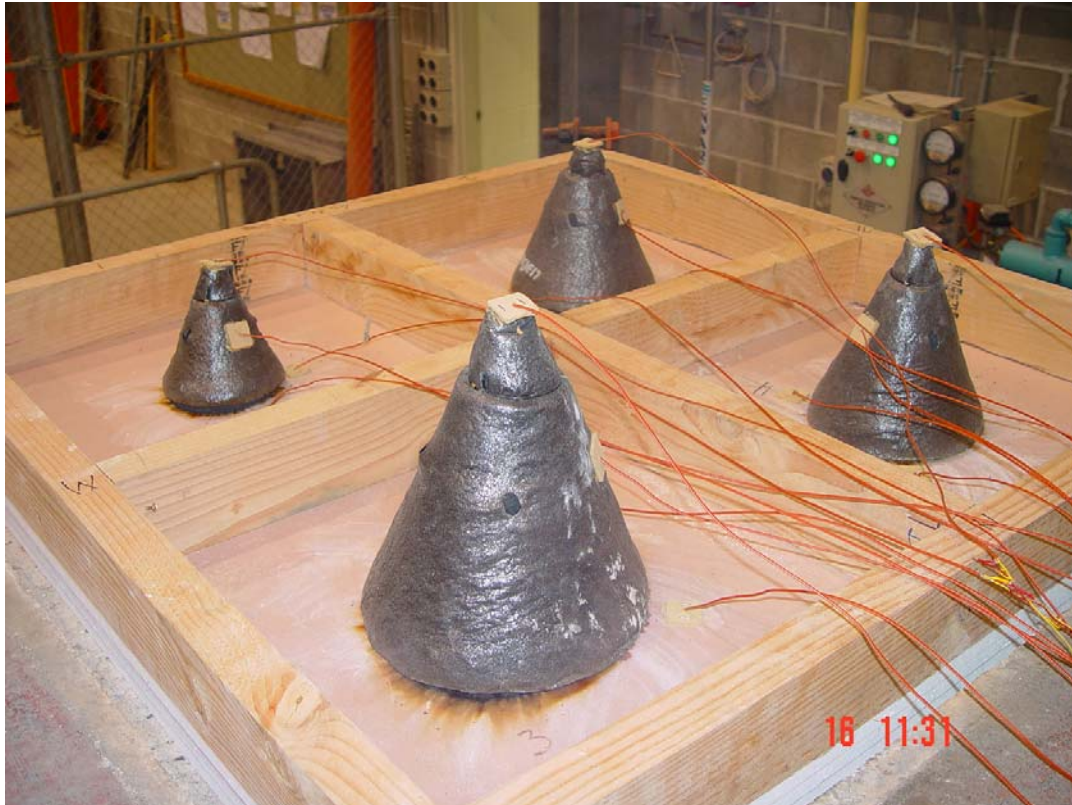
Photograph 3 - Specimen at 24 minutes into the test

- 10 minutes - Charring on the plasterboard, around the base of Sample 3.
- 11 minutes - Smoke quantity emitted from Sample 3 has decreased.
- 22 minutes - Some discolouration of plasterboard is visible around the bases of Samples 1 and 3 (photograph 3).

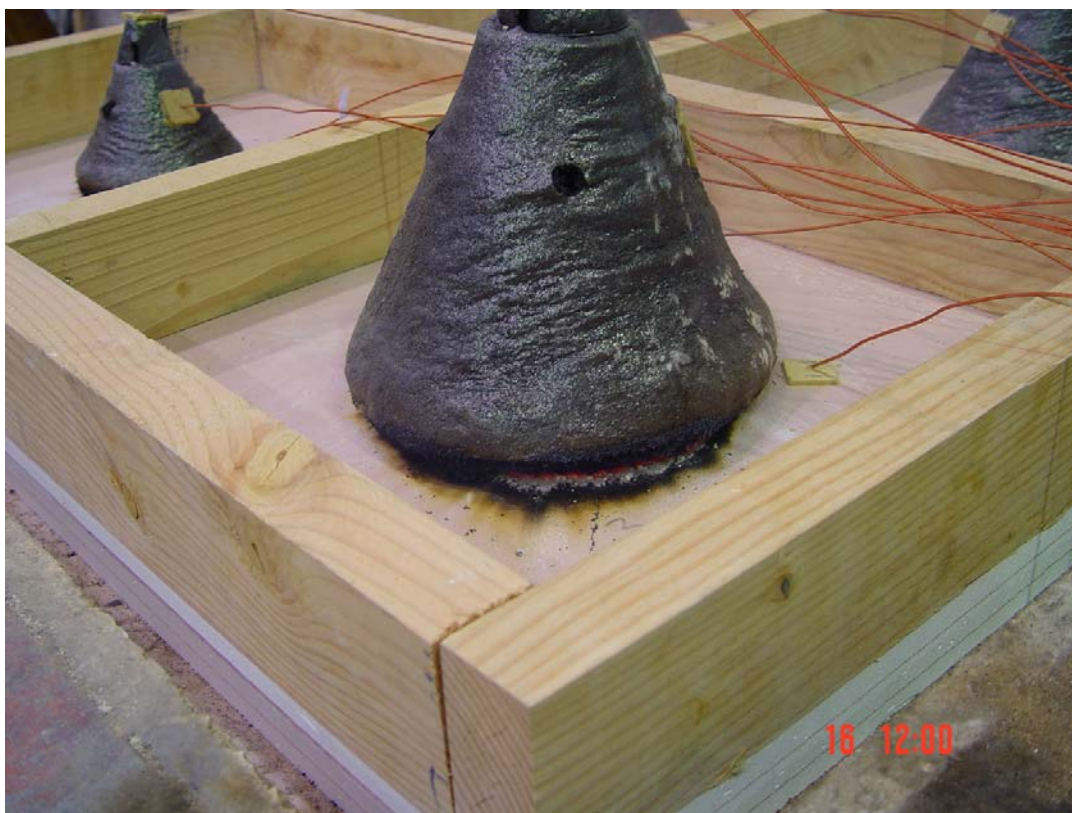
Photograph 4 - Sample 3 at 53 minutes into the test

- 32 minutes - All samples have risen up from the unexposed face of the plasterboard ceiling, as the specimen material intumesces.
- 44 minutes - Red glow is visible around the base of Sample 3 (photograph 4).

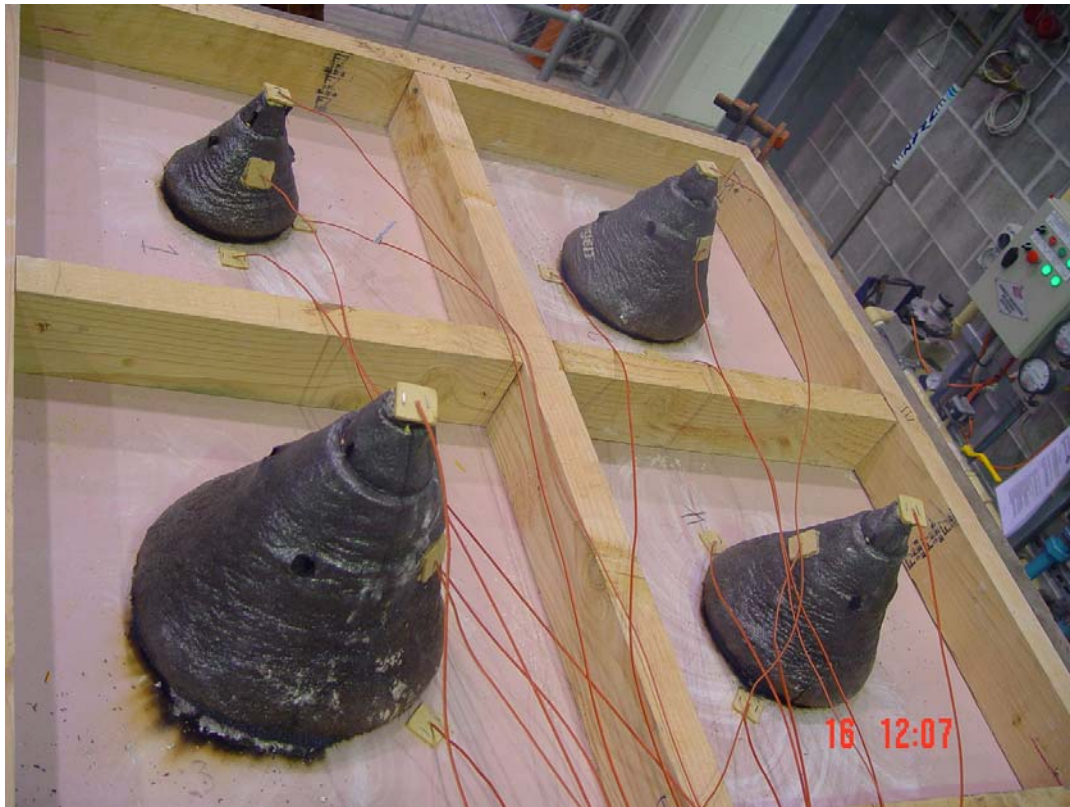
Photograph 5 - Specimen at 60 minutes into the test

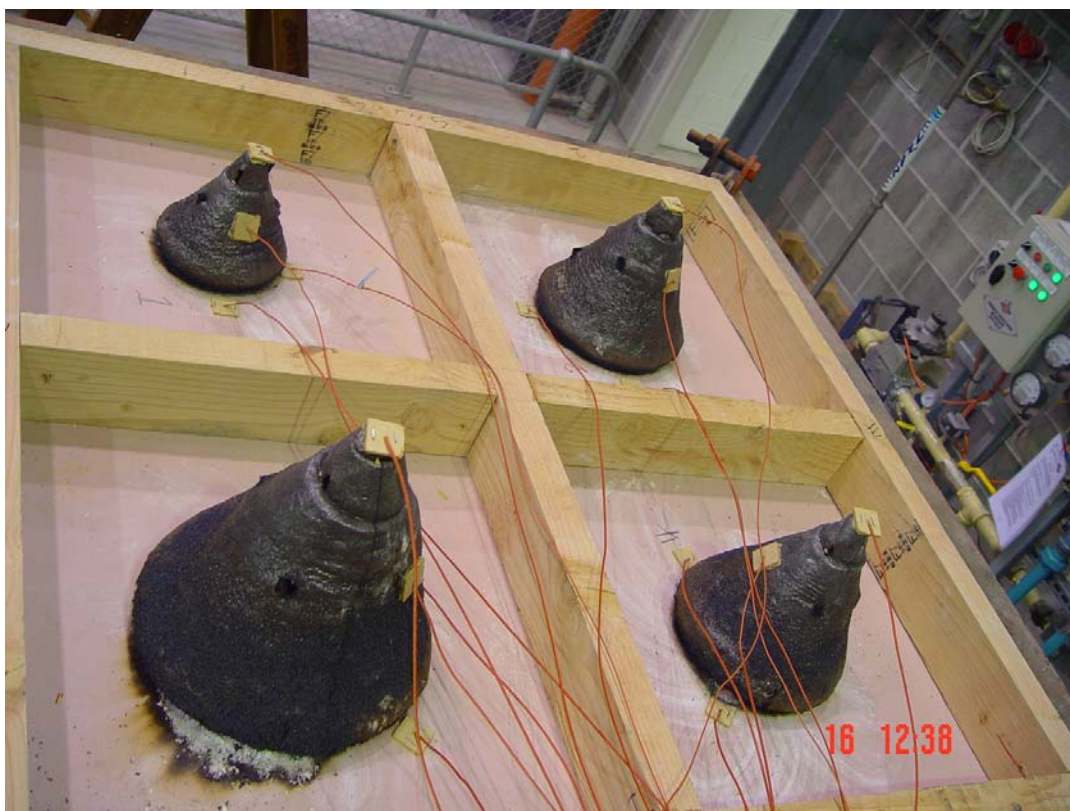
Photograph 6 - Specimen at 91 minutes into the test

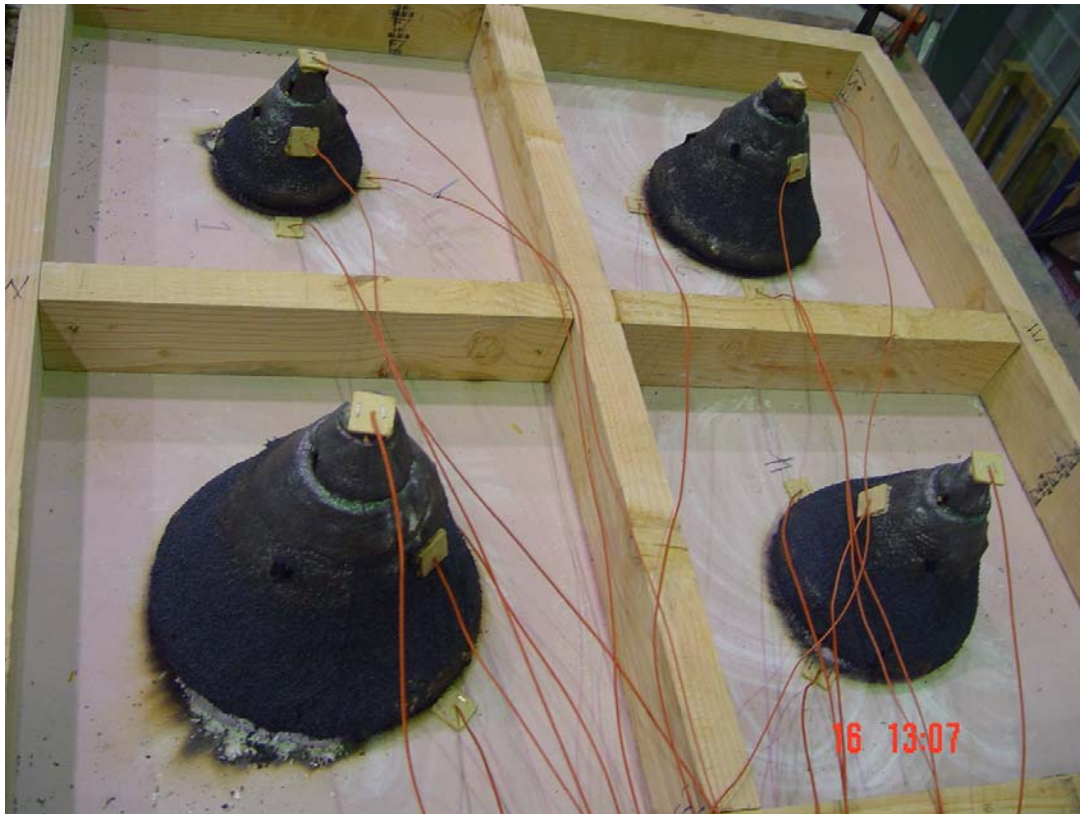
Photograph 7 - Specimen at the completion of testing

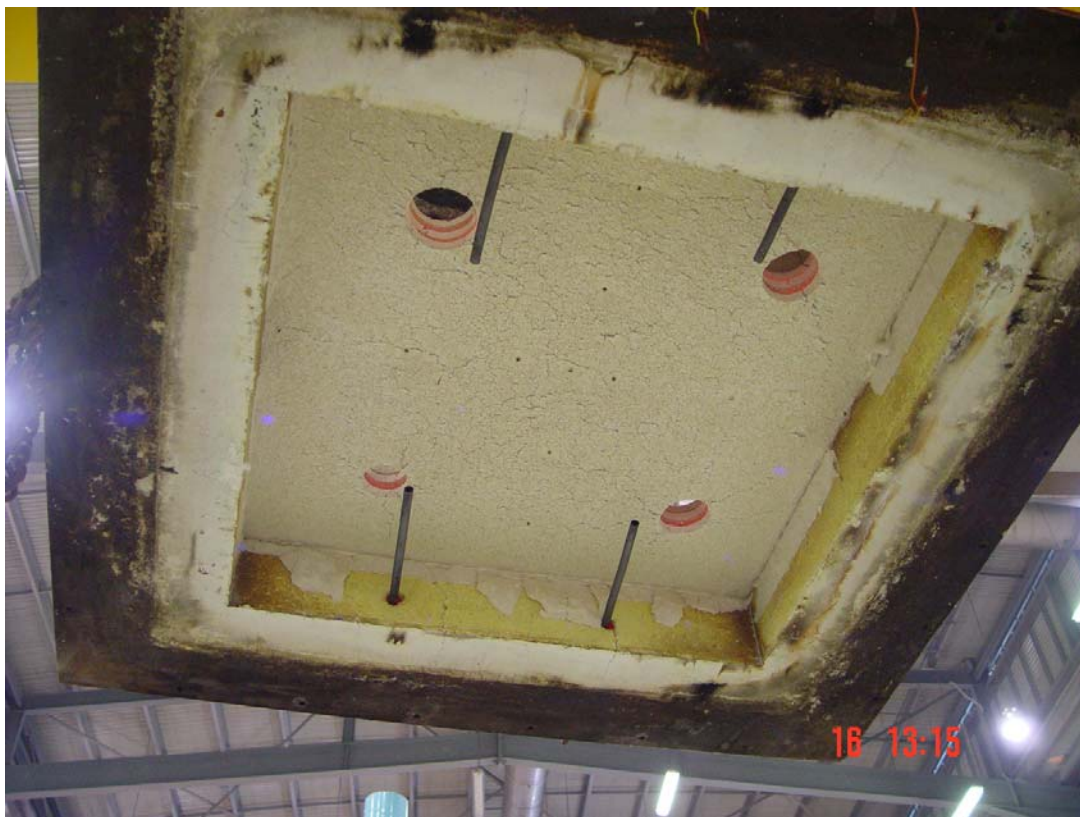
Photograph 8 - Exposed face of the specimen after the completion of testing

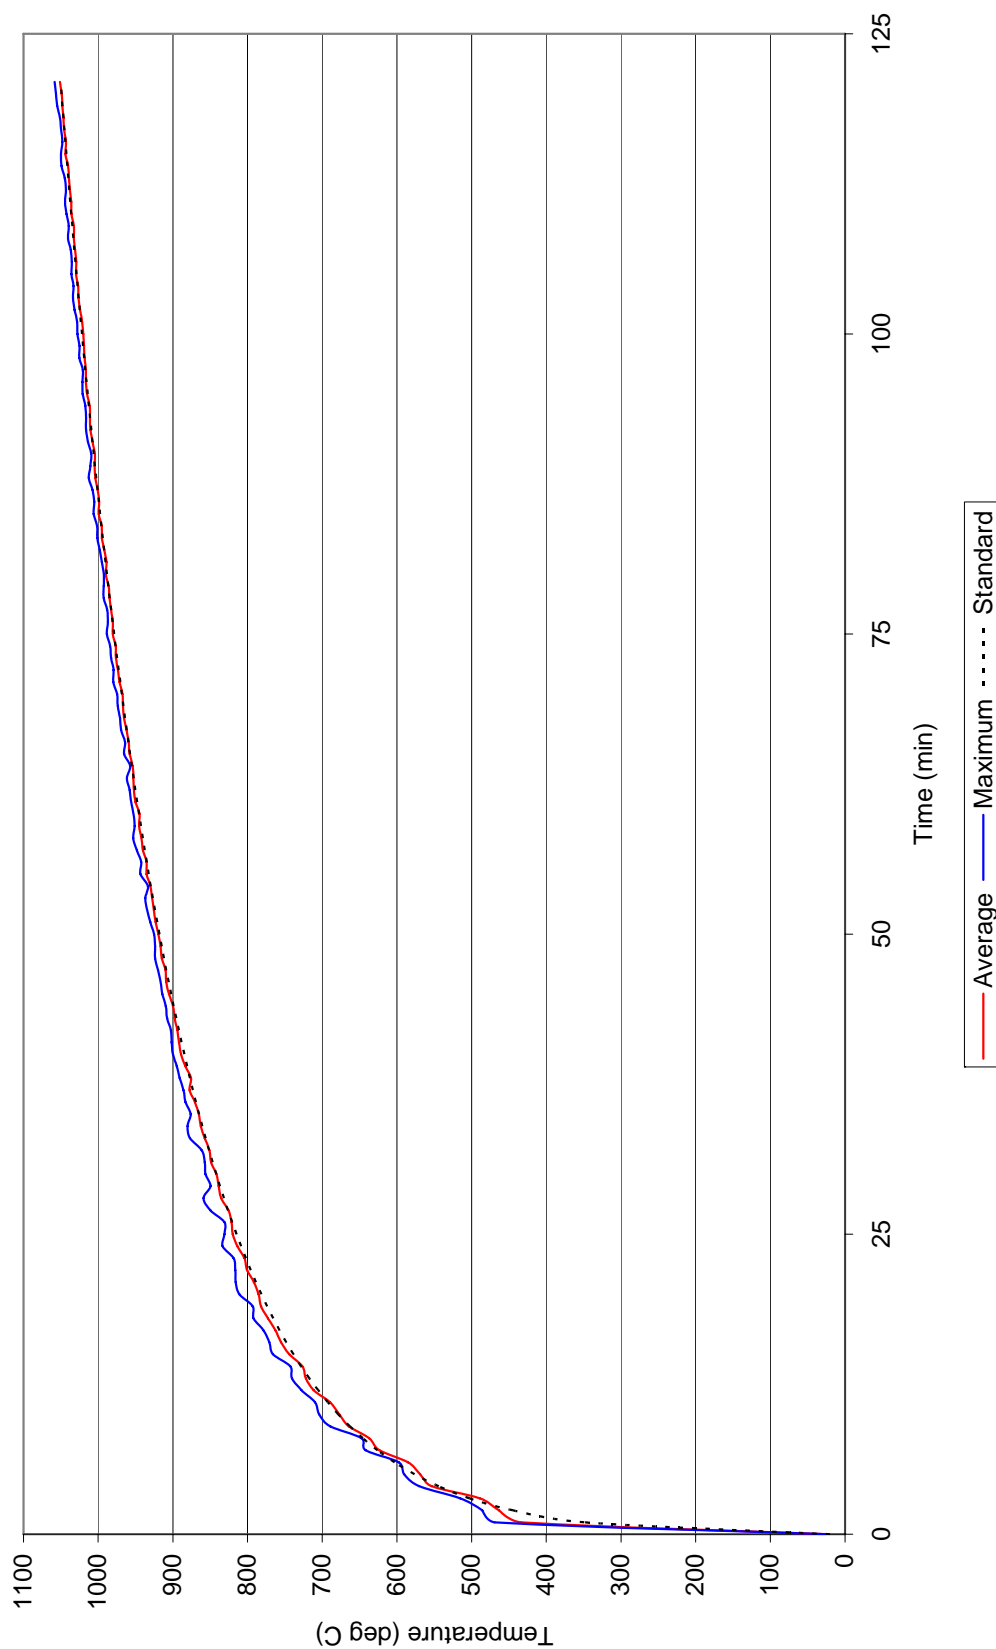
Figure 1- Furnace temperature

Figure 1 shows the standard curves of temperature versus time for heating the furnace chamber and the actual curves of average and maximum temperature versus time recorded during the heating period.

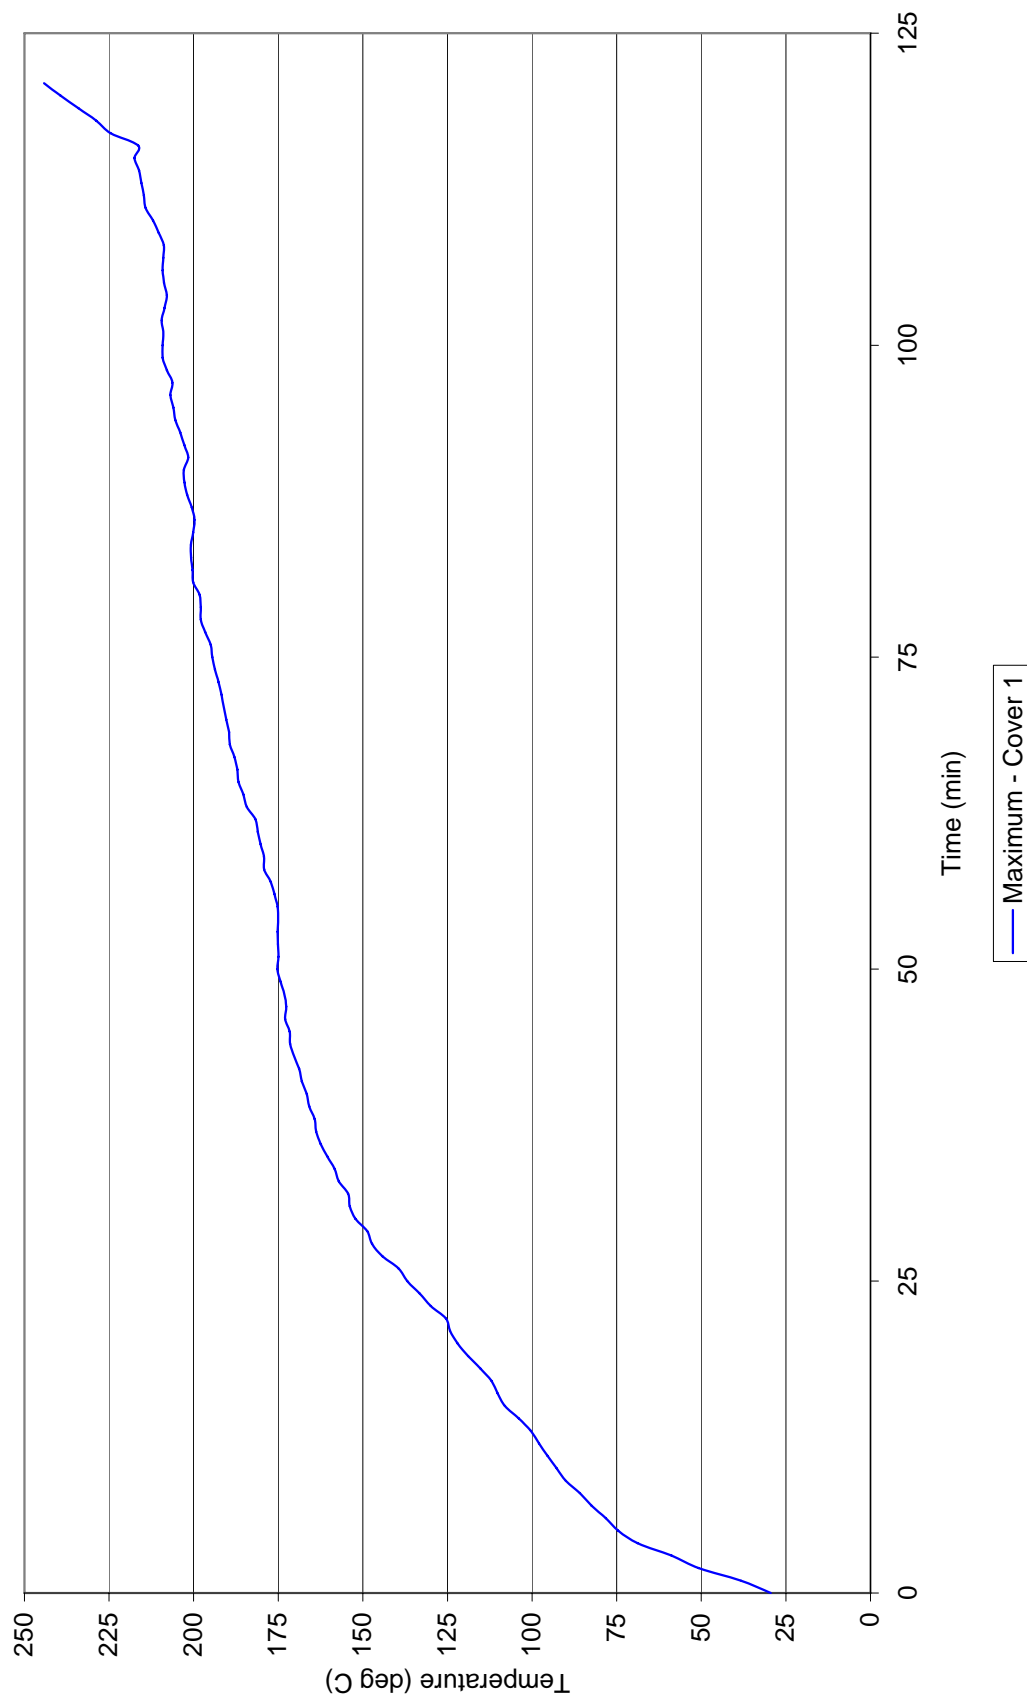
Figure 2 - Specimen temperature – SAMPLE 1

Figure 2 shows the curve of maximum temperature versus time associated with Sample 1.

Structural adequacy	-	not applicable
Integrity	-	no failure at 121 minutes
Insulation	-	105 minutes

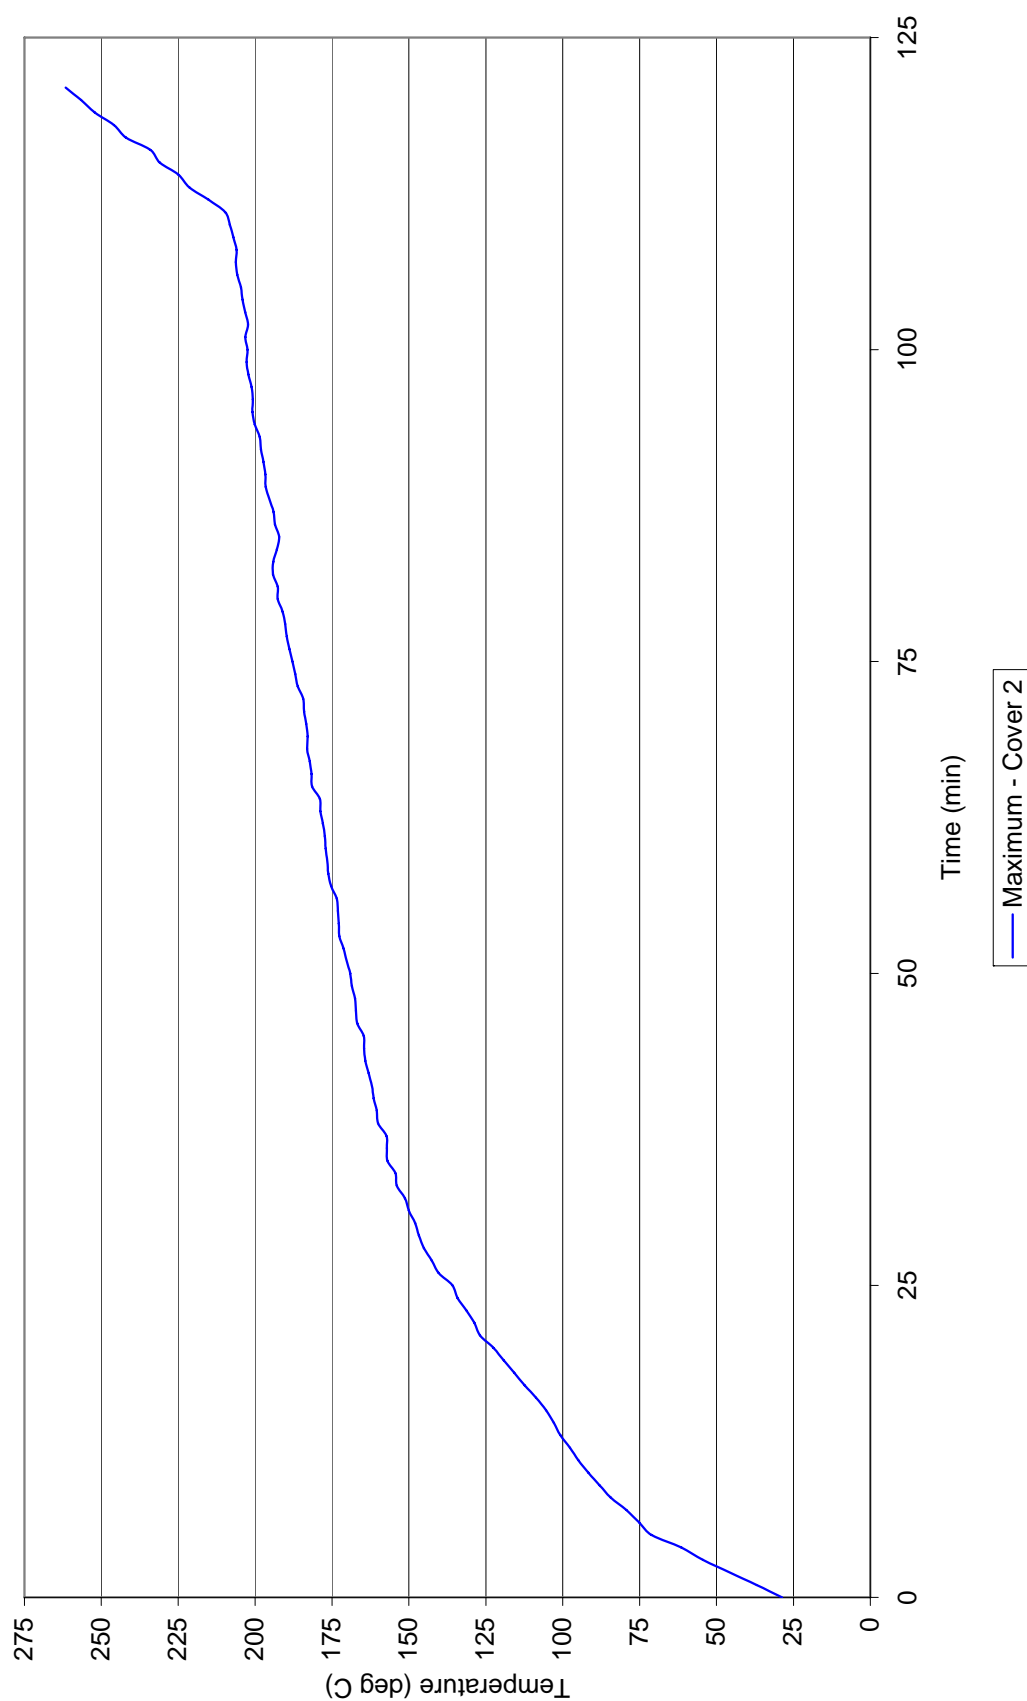
Figure 3 - Specimen temperature – SAMPLE 2

Figure 3 shows the curve of maximum temperature versus time associated with Sample 2.

Structural adequacy	-	not applicable
Integrity	-	no failure at 121 minutes
Insulation	-	111 minutes

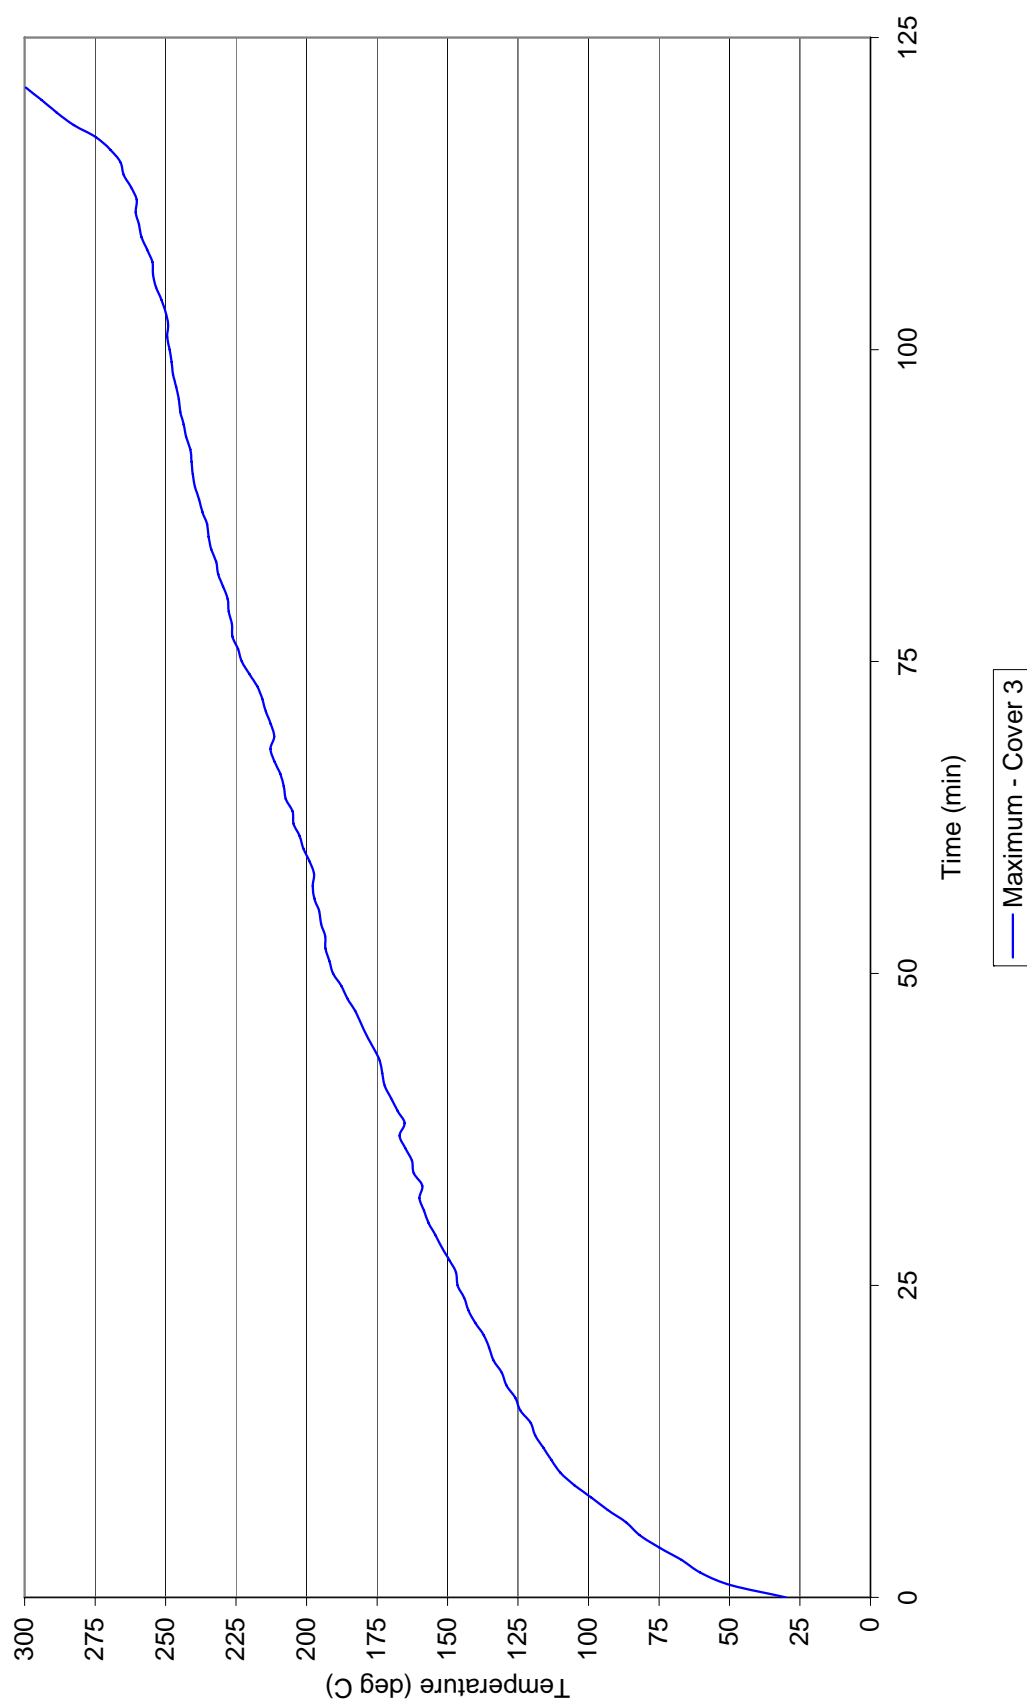
Figure 4 - Specimen temperature – SAMPLE 3

Figure 4 shows the curve of maximum temperature versus time associated with Sample 3.

Structural adequacy	-	not applicable
Integrity	-	no failure at 121 minutes
Insulation	-	63 minutes

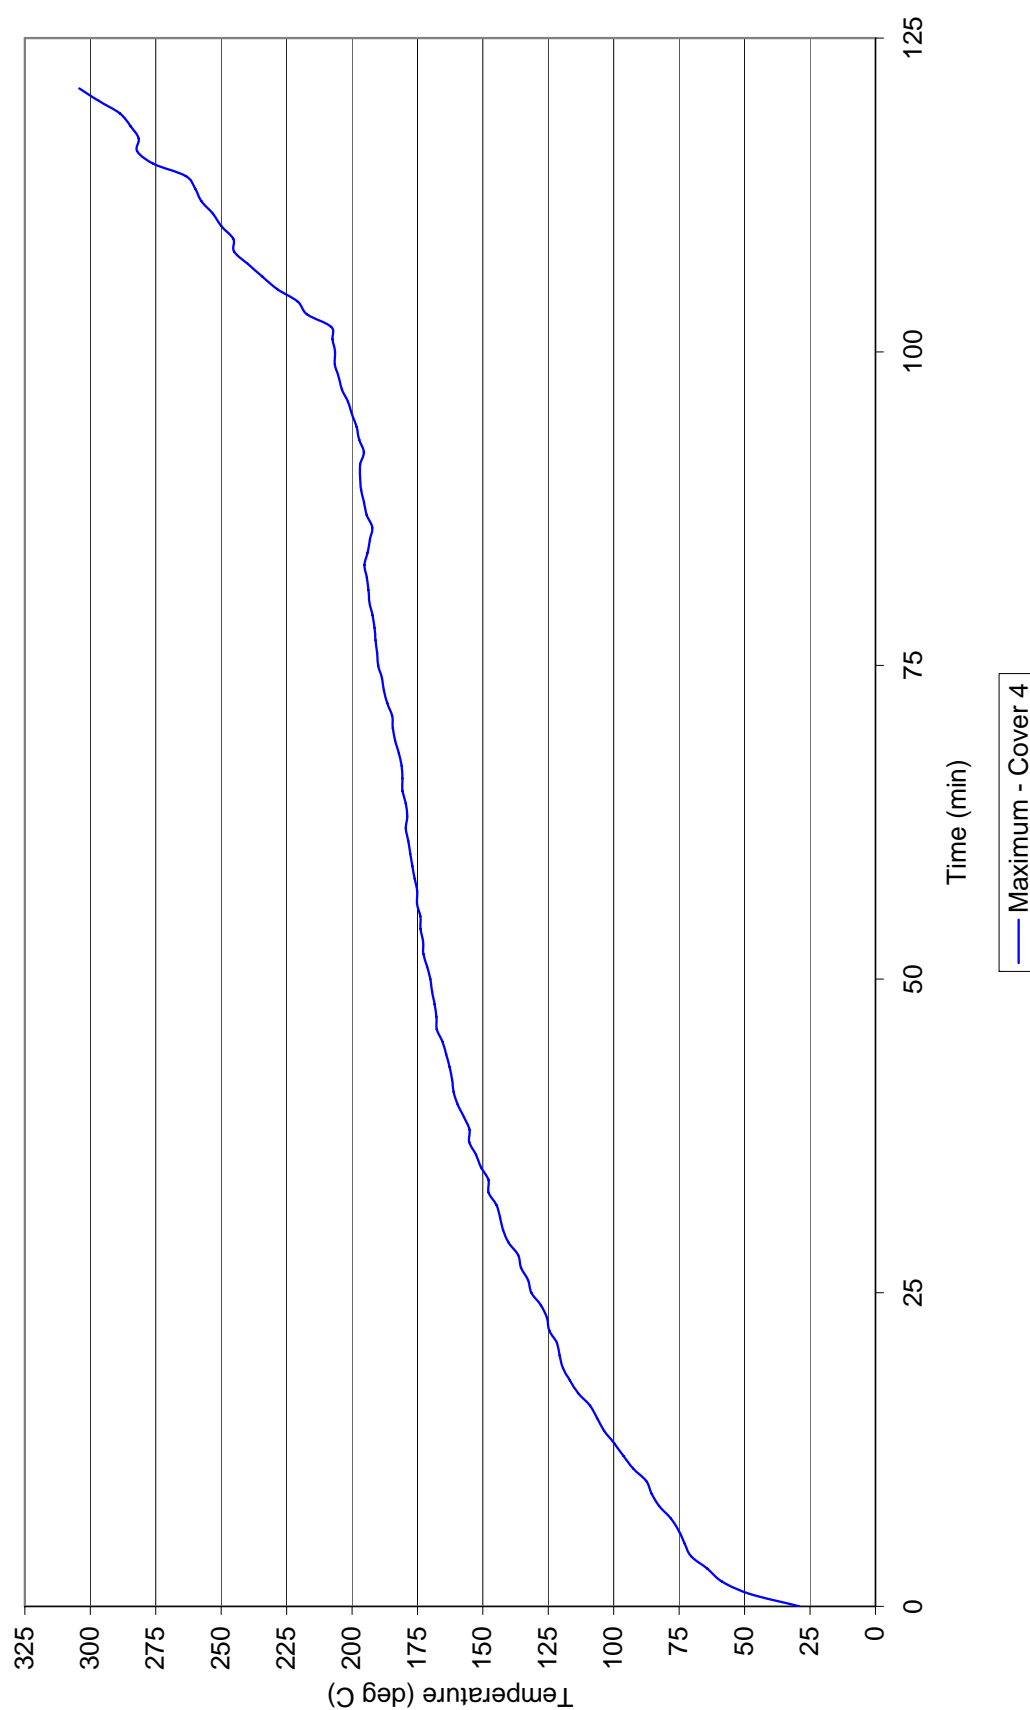
Figure 5 - Specimen temperature – SAMPLE 4  
APPENDIX 3

Figure 5 shows the curve of maximum temperature versus time associated with Sample 4.

Structural adequacy	-	not applicable
Integrity	-	no failure at 121 minutes
Insulation	-	102 minutes

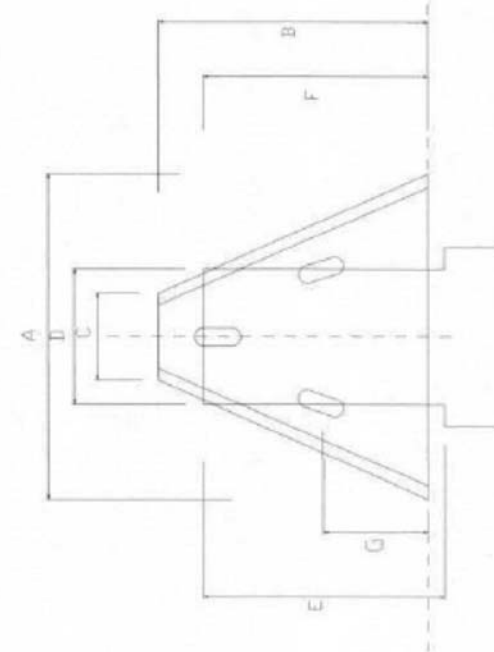
## Drawing 1

Efficiency Matrix Mitt Products  
Specification Drawing No.1, Date: 16 Oct, 2007

Mitt	SMALL	MIDDLE	LARGE
A	150	200	250
B	160	210	270
C	30	30	30
D	50	50	70
E	130	195	235
F	125	190	230
G	85	120	140
Wall Thk	10	10	12

On the unexposed face of the ceiling, the downlight assembly was protected by a 150-mm Small Basic Mitt. The hood was made out of 10-mm thick intumescent based material, formed into a conical shape, measuring 150-mm in diameter at its base and 160-mm in height. The hood incorporated small oval openings, four of which were located at 85-mm from the base and two at 130-mm from the base.

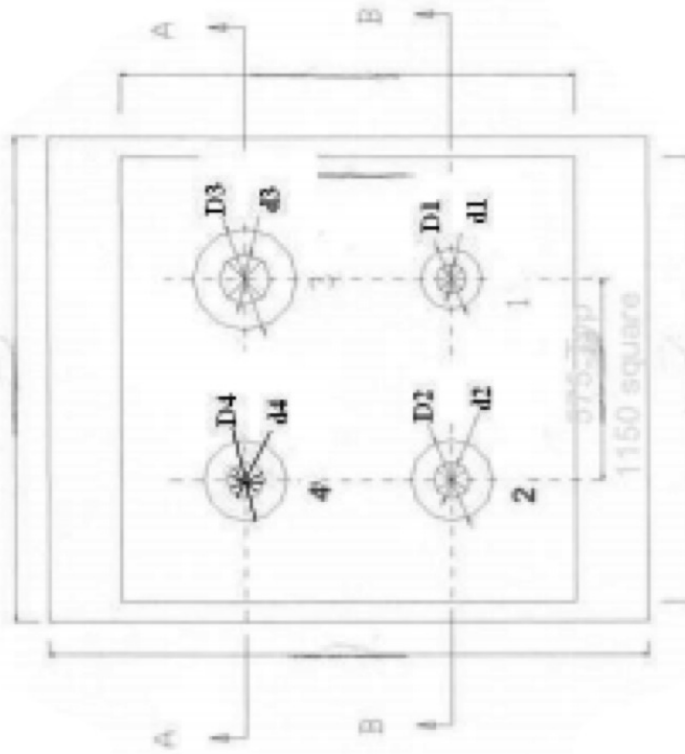
Drawing 2

Efficiency Matrix Mitt Products  
Specification Drawing No.2, Date: 16 Oct, 2007

1. 150 SMALL VENTILATED DOWNLIGHT MITT WITH 50mm (d1) DOWNLIGHT FITTED, Cutout DIA is 70mm (D1)
2. 200 VENTILATED DOWNLIGHT MITT/BASIC MITT WITH 65mm (d2) DOWNLIGHT FITTED, Cutout DIA is 90mm (D2)
3. 250 VENTILATED LOFT MITT WITH 75mm (d3) DOWNLIGHT FITTED, Cutout DIA is 105mm (D3)
4. 200 VENTILATED DOWNLIGHT MITT/BASIC MITT WITHOUT DOWNLIGHT (d4), Cutout DIA is 90mm (D4)

## Plan of test Speciman

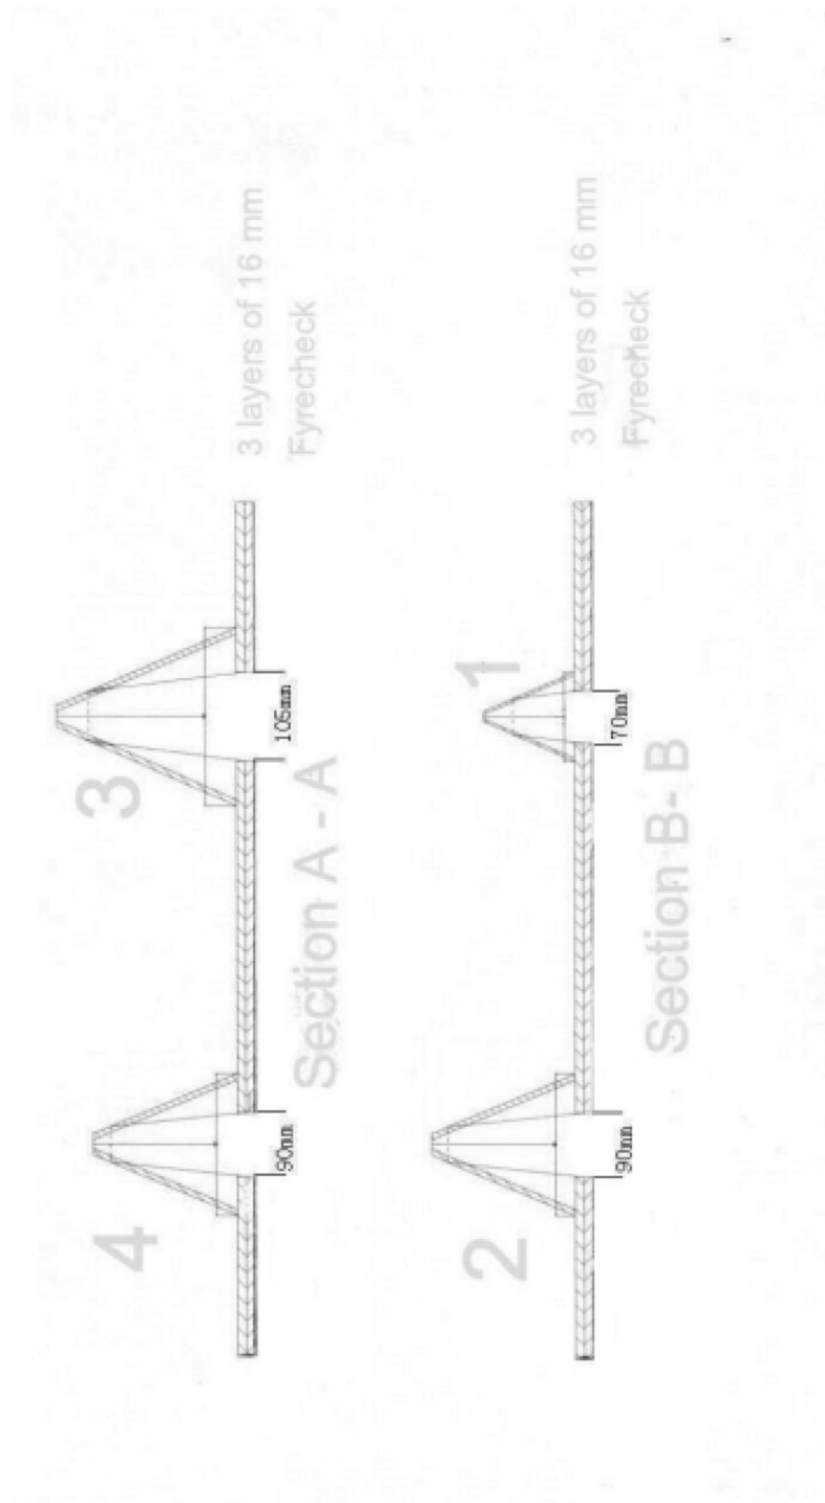
Drawing 3

Efficiency Matrix Mitt Products  
Specification Drawing No.3, Date: 16 Oct, 2007

1. 150 SMALL VENTILATED DOWNLIGHT MITT WITH DOWNLIGHT
2. 200 VENTILATED DOWNLIGHT MITT/BASIC MITT WITH DOWNLIGHT
3. 250 VENTILATED LOFT MITT WITH DOWNLIGHT
4. 200 VENTILATED DOWNLIGHT MITT/BASIC MITT WITHOUT DOWNLIGHT
