<b>Air Leakage Measurement Australia</b>	ABN:46109799171 4 Bannister Gardens Griffith ACT 2603
--	--

## Air Leakage Test Report on Efficiency Matrix Downlight Mitt

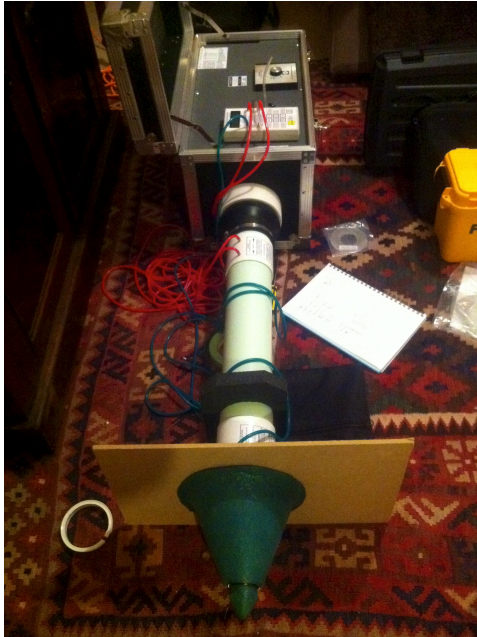
Figure 1. Photograph of test rig

The test assembly comprised of a MDF board with a 10cm diameter Masson gimble downlight fitted through a 9cm diameter hole. The flange of the downlight was flush with the MDF as would be a gyprock mounted fitting. The light fitting contained a standard 50W 12V halogen globe.

The downlight fitting was attached to the 16cm<sup>2</sup> using an airtight seal of putty between the tube and MDF board. Note that the downlight was fitted with the front side facing the DM1 and airflow moving from back to front. A multipoint test was taken leakage from 5 pressures ranging from ~160 Pa down to ~25Pa. The rig was allowed 30 seconds to stabilise at the set pressure and 4 second was applied to the reading to reduce the effect of any fluctuation.

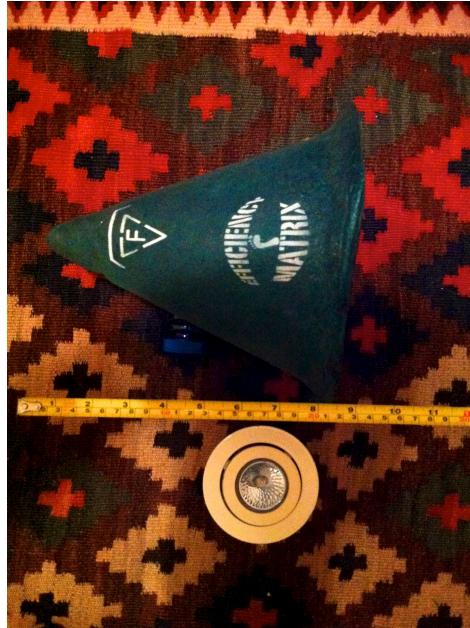
Figure 2. Photograph of mitt and downlight

The Downlight Mitt is a non ventilated downlight product which focuses on fixing the inefficiencies of downlights. The Downlight cover is made out of an intumescent/insulative material taking downlight safety to a new level, while also providing an R-value of 0.5 above the luminaire. This product is primarily designed to be installed from below the ceiling through a 90mm cut out, but can be installed above the ceiling as well. The downlight mitt is 25cm tall with an 18cm internal diameter at the widest point.

The test was performed on the uncovered downlight as well as the same downlight covered with a Efficiency Matrix downlight mitt. The mitt was held in place using the wire fastening device that is supplied with each mitt.
